MOTOR GRADER TEST

Rome Grader - Model 402,

San Bernardino National Forest,

January 23 - March 15, 1950

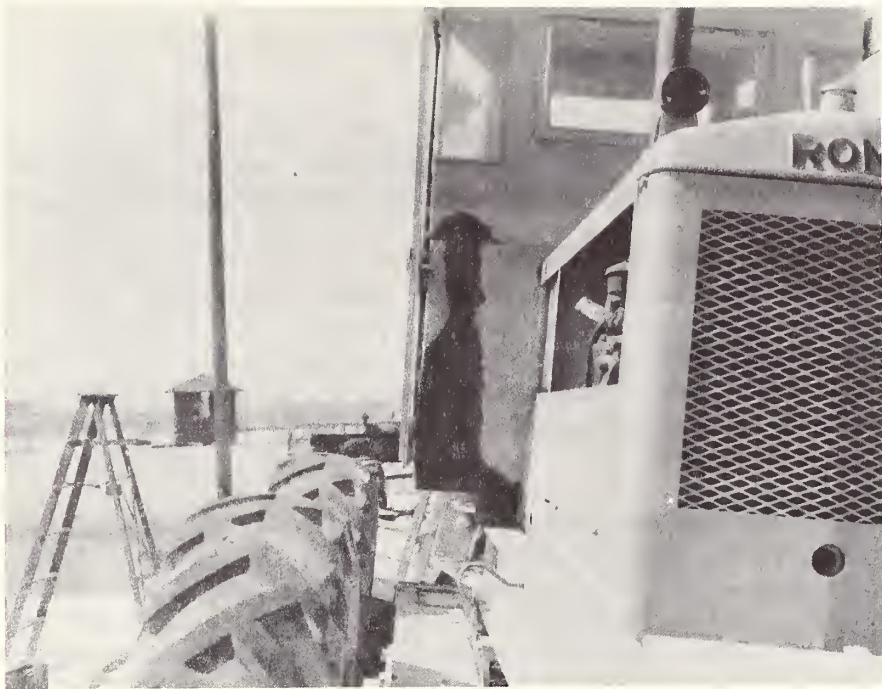
The sizes and weights of the box section frame are average as compared to other machines. However, due either to design or weight distribution on the frame itself, the frame showed extreme flexibility. From chalk marks put on the rear of the cab, it was shown that the relative motion between the vertical center lines of cab and engine was approximately 2°. This flexibility was extremely noticeable in the heavier work such as encountered in the ditching tests, but was evident during all operations. Flexing in this respect will ordinarily result in eventual structural failure and may be a decided factor in blade flexibility complaints which are discussed under Blade Operation. The arrows in photograph, Fig. 7, show the range of this movement.

Fig. 7. Flexing shown by Arrows on Cab

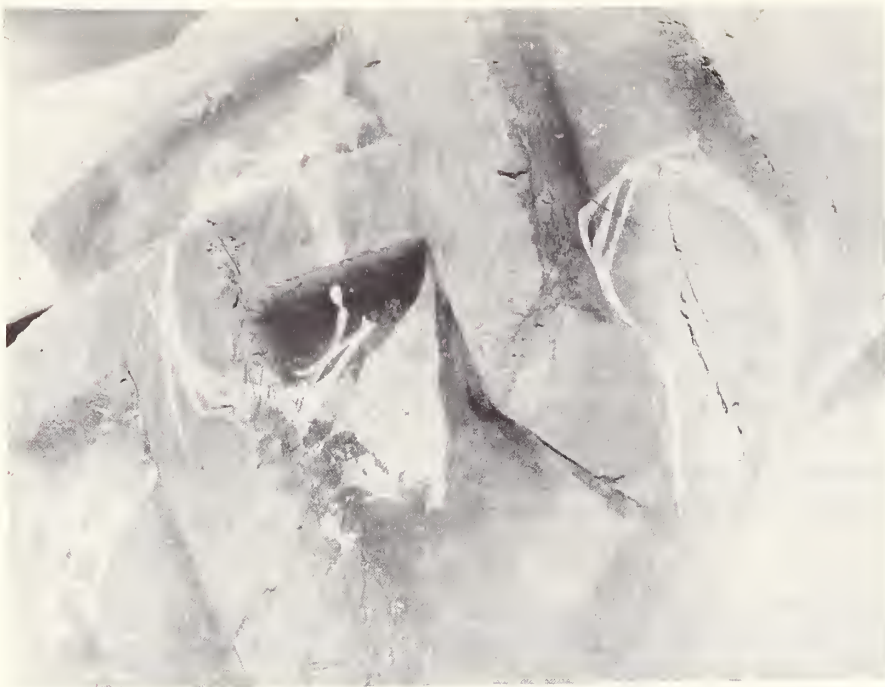
Tires as furnished were Firestone 13.00x24 - 12 ply, and rated with the heaviest in the 13.00 size. Final inspection on completion of test showed tires to be badly worn and cut. See Figures 14 and 15.

Fig. 14. Tire Cut - Rear Tandem

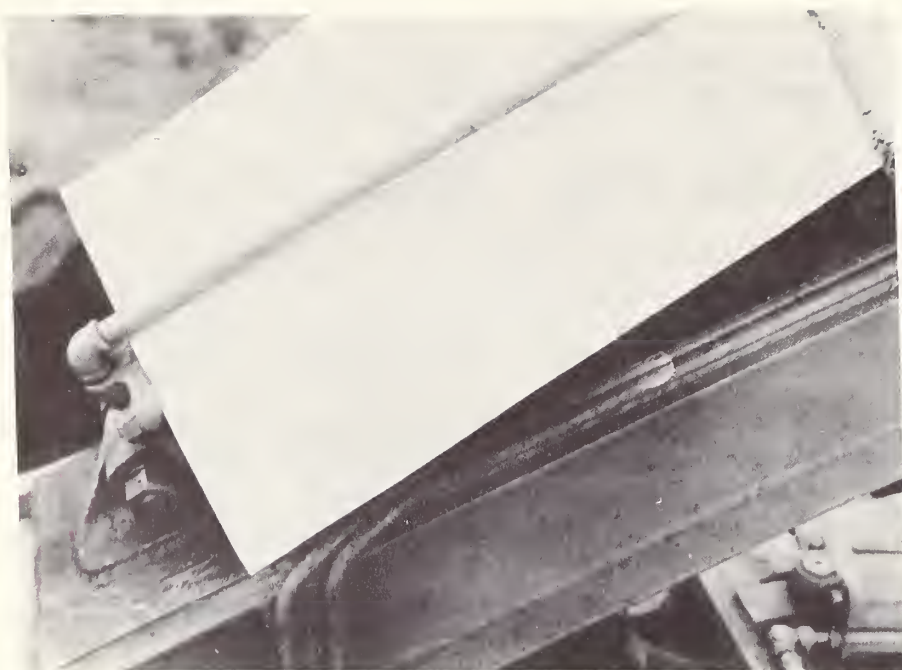
- D. The pipe which extended the full length of the scarifier cylinder was not anchored. One end of the pipe attached to lower end of cylinder with a street ell, and the other end attached to a flexible hydraulic hose line. The pipe was subject to vibration and swung free on the street ell. Pipe breakage or oil leaks could be anticipated at this point. The final check showed seepage at the ell. Refer to photograph - Fig. 21.

Fig. 21. Scarifier Cylinder Feed Line

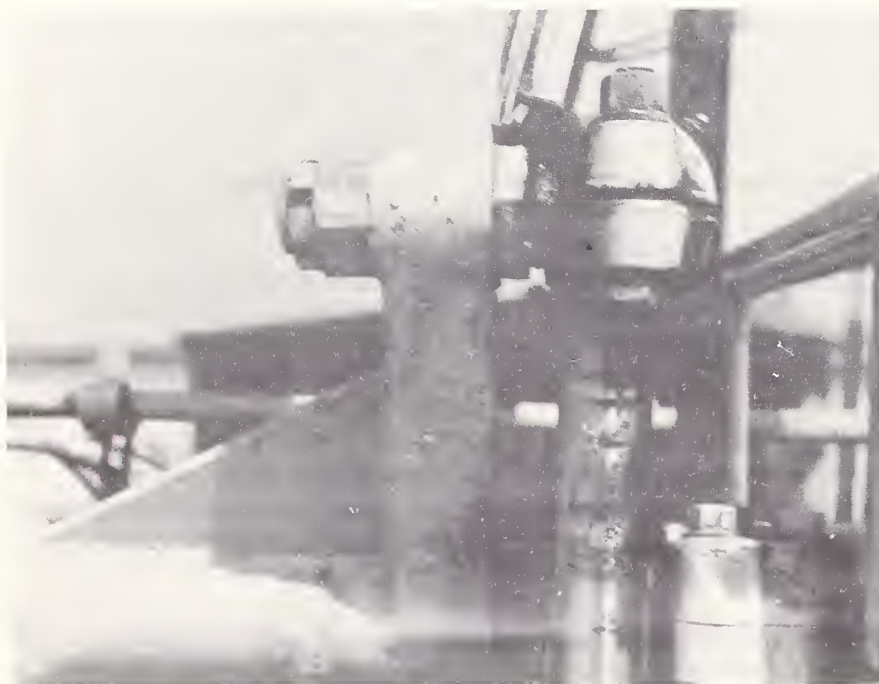
With the windshield partially opened, it was directly in the path of the lift ram and could be knocked off. See photograph - Fig. 24.

Fig. 24. Lift Ram Hits Windshield

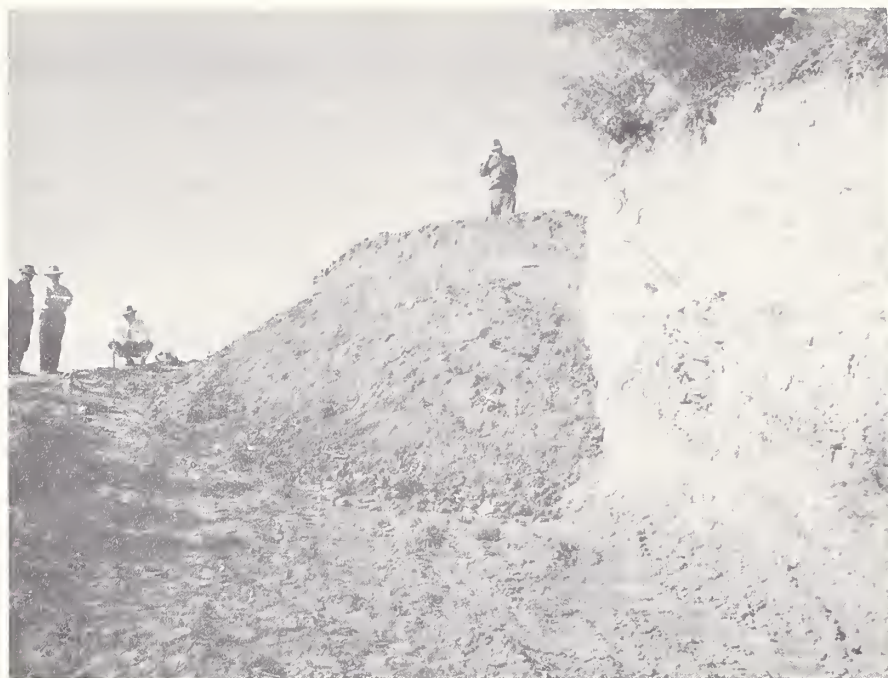
Climbing ability of the Rome in this test was considered adequate. Inability to swing blade under scarifier and difficulty with transmission controls hindered operations. It is of interest that the other machine which was considered to have a low weight horsepower ratio rated fourth in time to complete the test. Figures 25 and 26 show the slide before and after being worked on by the Rome.

Fig. 25. Slide - Before Test

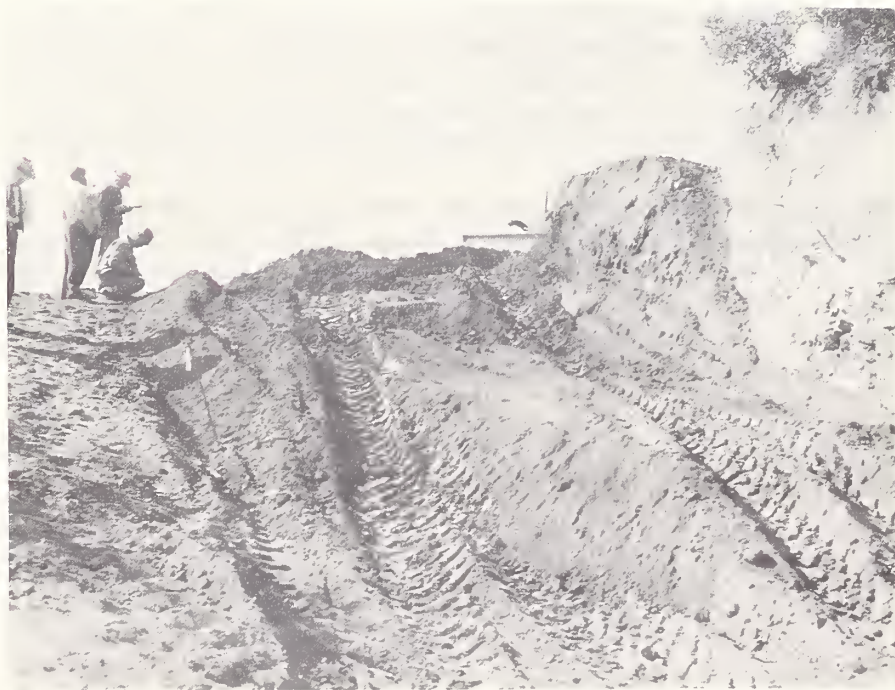
Fig. 26. Slide - Completion of Test

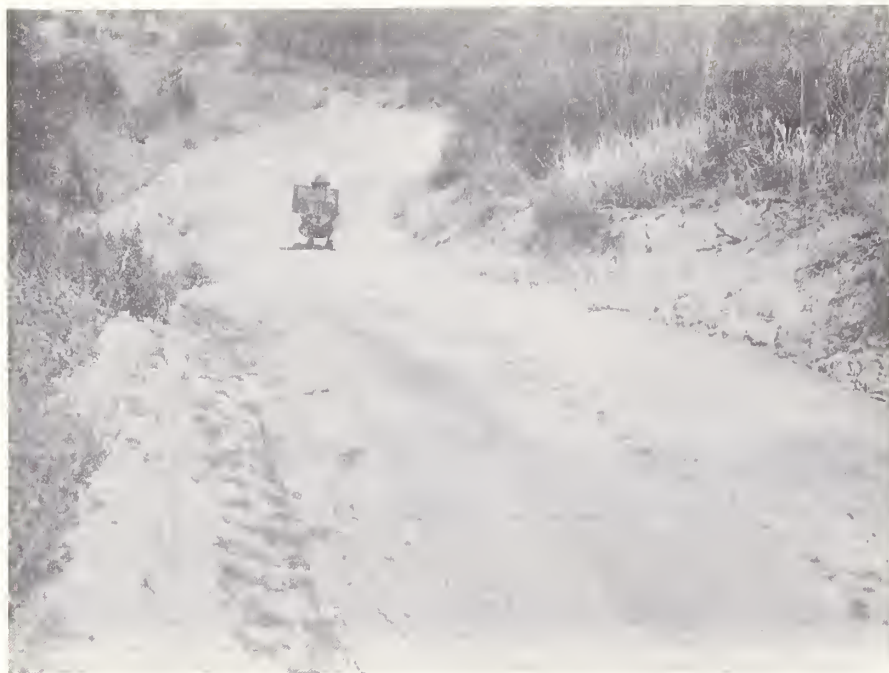
In the grading of dips, the Rome 402 had difficulty. The short total vertical blade travel, and the instability of the blade, made for poor operation. With the blade set for normal operation, the blade would clear the summit of the dip but did not have sufficient drop to properly grade the section in the runoff trough. Set for proper grading of the trough section, the blade could not be lifted sufficiently to clear the summit. Fig. 27 shows a shot of a dip before passage of the grader. The following photograph, Fig. 28, shows an after shot taken from the same position. Examination of the bank line where sluff was removed shows the erratic motion of the right side of the blade. Instead of cleaning out the trough section, the left side of the blade was unable to go even to the filled level, and actually deposited unwanted material. In the construction of dips, the same difficulty was encountered.

Fig. 27. Dip - Before Maintenance

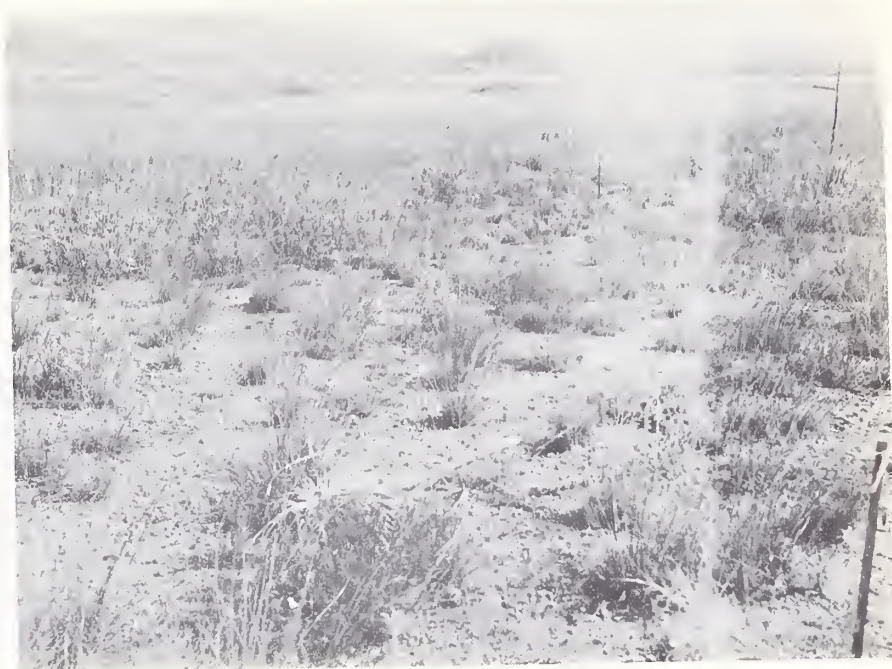
Fig. 29. Ditching Site Before Operation

The site of this ditching operation, photograph Fig. 29, was in the same area as those worked on by other units. Adjacent strips immediately to right and left were worked on by other machines. The comparative time for the ditching test showed the Rome 402 to be 1 hour and 11 minutes slower than the next machine. The comparative table of ditching time, Table XIX, shows the overall spread between the Rome 402 and the other machines in the test.

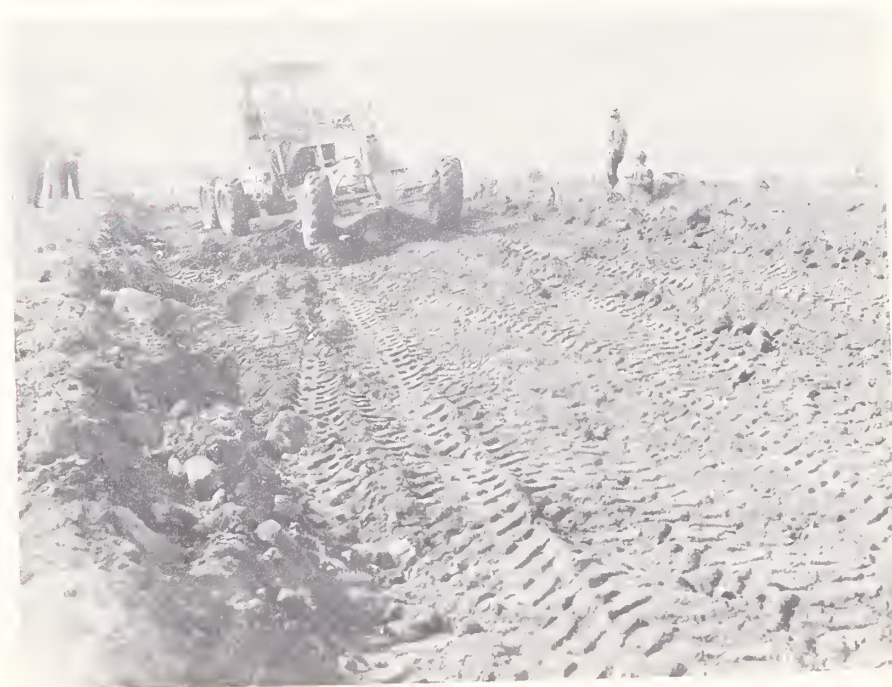
Fig. 30. Ditching - During Operations

Figures 30 and 31 show the cut bank before and after attempts to bank slope to the required $3/4:1$ slope. All attempts to do this with the machine in the ditch were futile and the final cut was made with the machine straddling the cut bank. At the completion of this test it was evident that conclusions regarding bank slope ability, made during the flat land tests were pertinent. A movie sequence taken during this operation clearly shows the difficulty experienced.

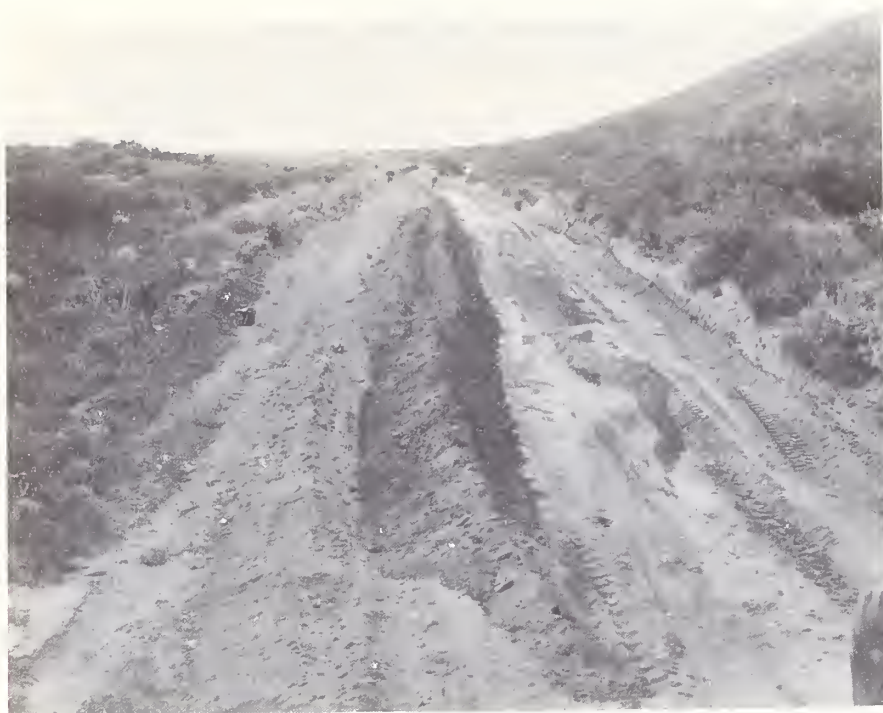
Fig. 35. Windrow Before Test

In production, the Rome rated fourth. Classification of the completed test by observers rated it as a very poor job. The roadbed was gouged in several places, with other sections covered with loose and scattered material. Lack of blade control and side thrust were again the main factors in the conclusions. At times, side thrust on the front end under heavy loading, made it difficult for the operator to keep the wheels from climbing the windrow.

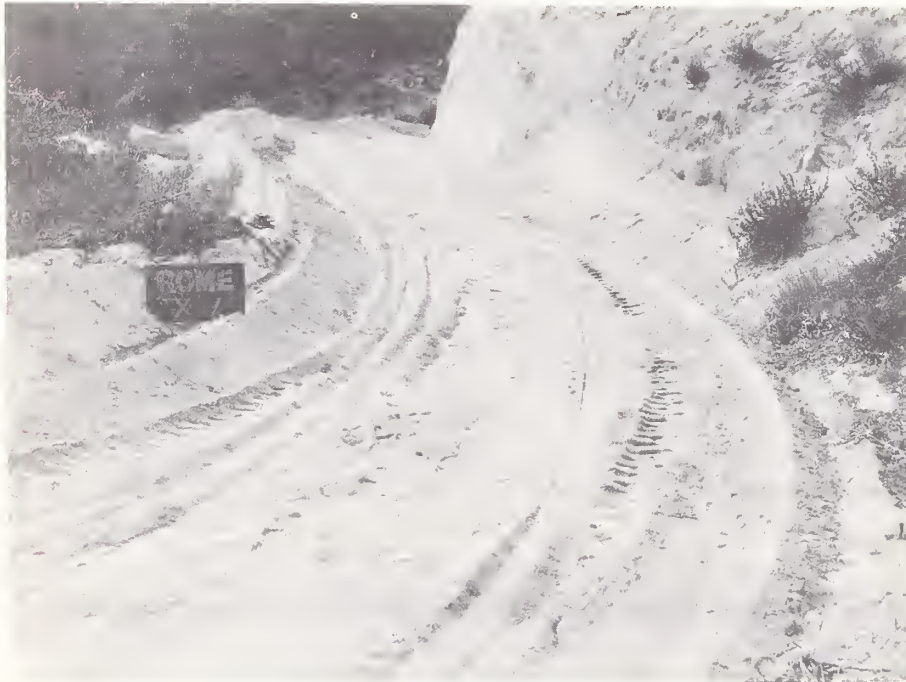
Fig. 38. Uphill Grading

In the uphill grading test, the operator's complaint was that with a fully loaded blade and opened throttle, the rear wheels spun badly. Movie sequences show considerable slippage of wheels during this test. As a result, the finished operation left a series of waves where the operator in attempting to reduce slippage raised the blade to reduce the load. Photograph, Fig. 38, shows a view of the uphill grading test section. The material of the road bed is decomposed granite and grades averaged 15%. Comparative Table XXII gives the overall time required for the graders to operate over a 500 ft. stretch in this operation.

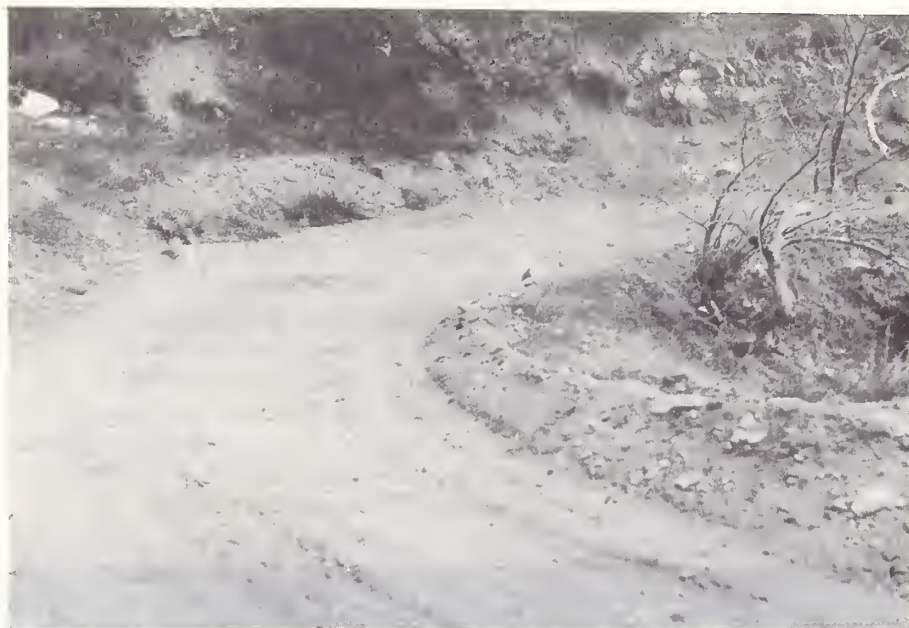
Fig. 39. Inside Curve Before Grading

Photographs, Figs. 39 and 40, show before and after shots of an in-curve. When conditions were favorable, fairly level ground, no heavy rock or other obstructions such as dips, ruts or heavy slough, performance was entirely adequate.

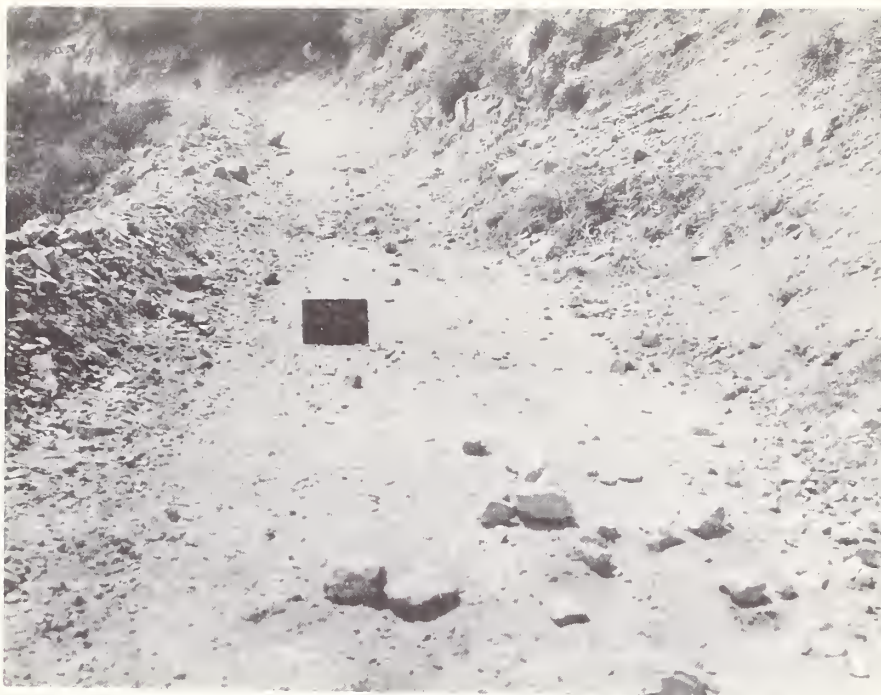
Fig. 42. Road Maintenance, Before

Photographs, Figs. 42 and 43, show before and after conditions of another typical section. The diagonal dirt ridge shown in Fig. 43 is an example of the result of blade instability and lack of control. Throughout the run similar conditions could be found, sometimes in the form of a ridge, other times as a gouge.
